Case studies and tools: Assessing the performance of stream and wetland restoration

Presented by: Kimberly Brewster Senior Project Manager Chagrin River Watershed Partners, Inc.

Case Studies and Tools: Assessing the Performance of Stream and Wetland Restoration

October 24, 2018

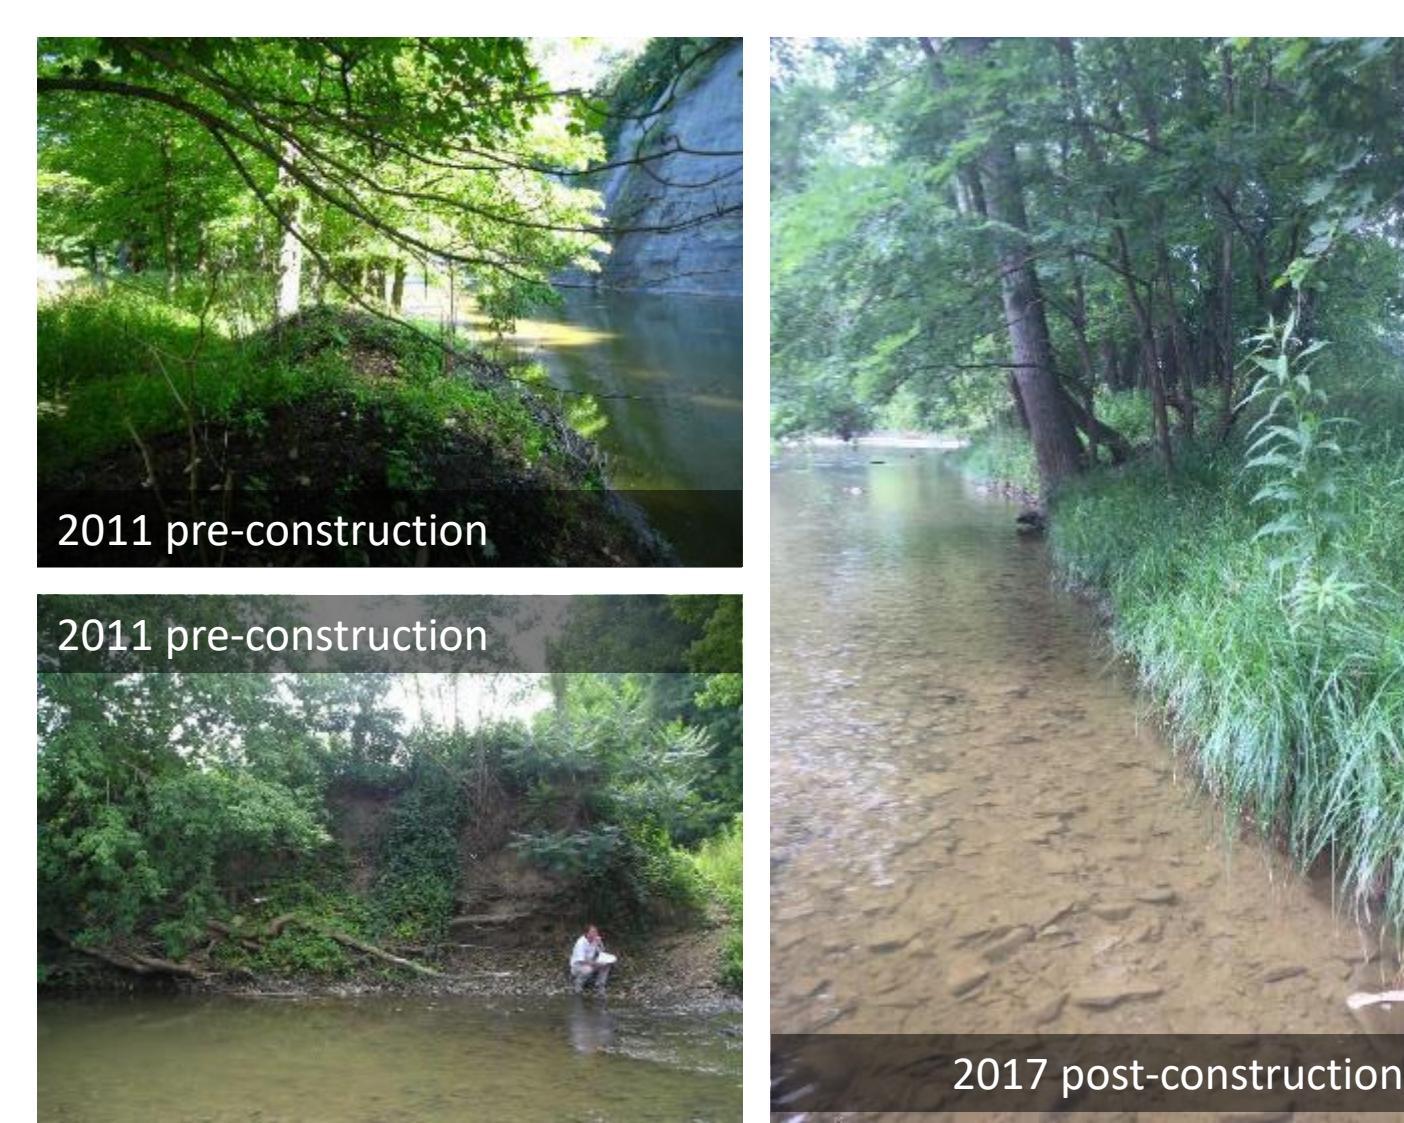
Indicators of improved floodplain access

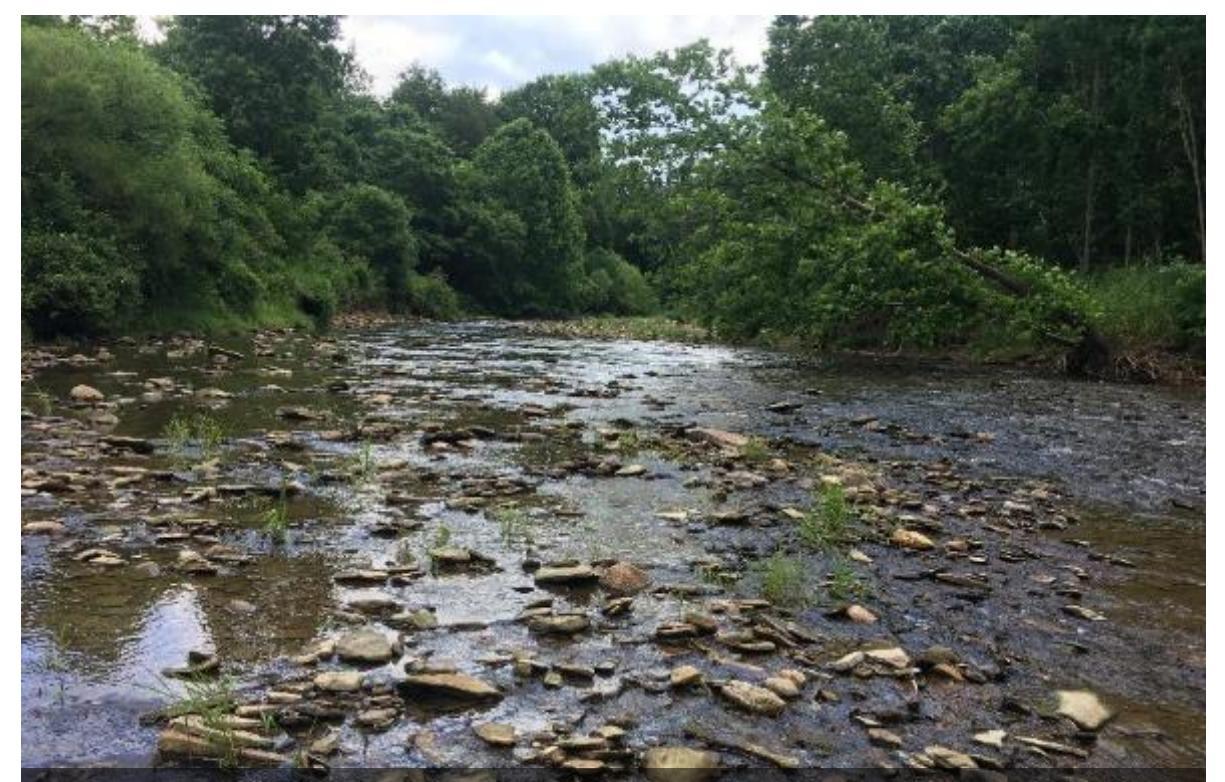
Upper Main Branch of the Chagrin River, upstream of restoration project, 2017

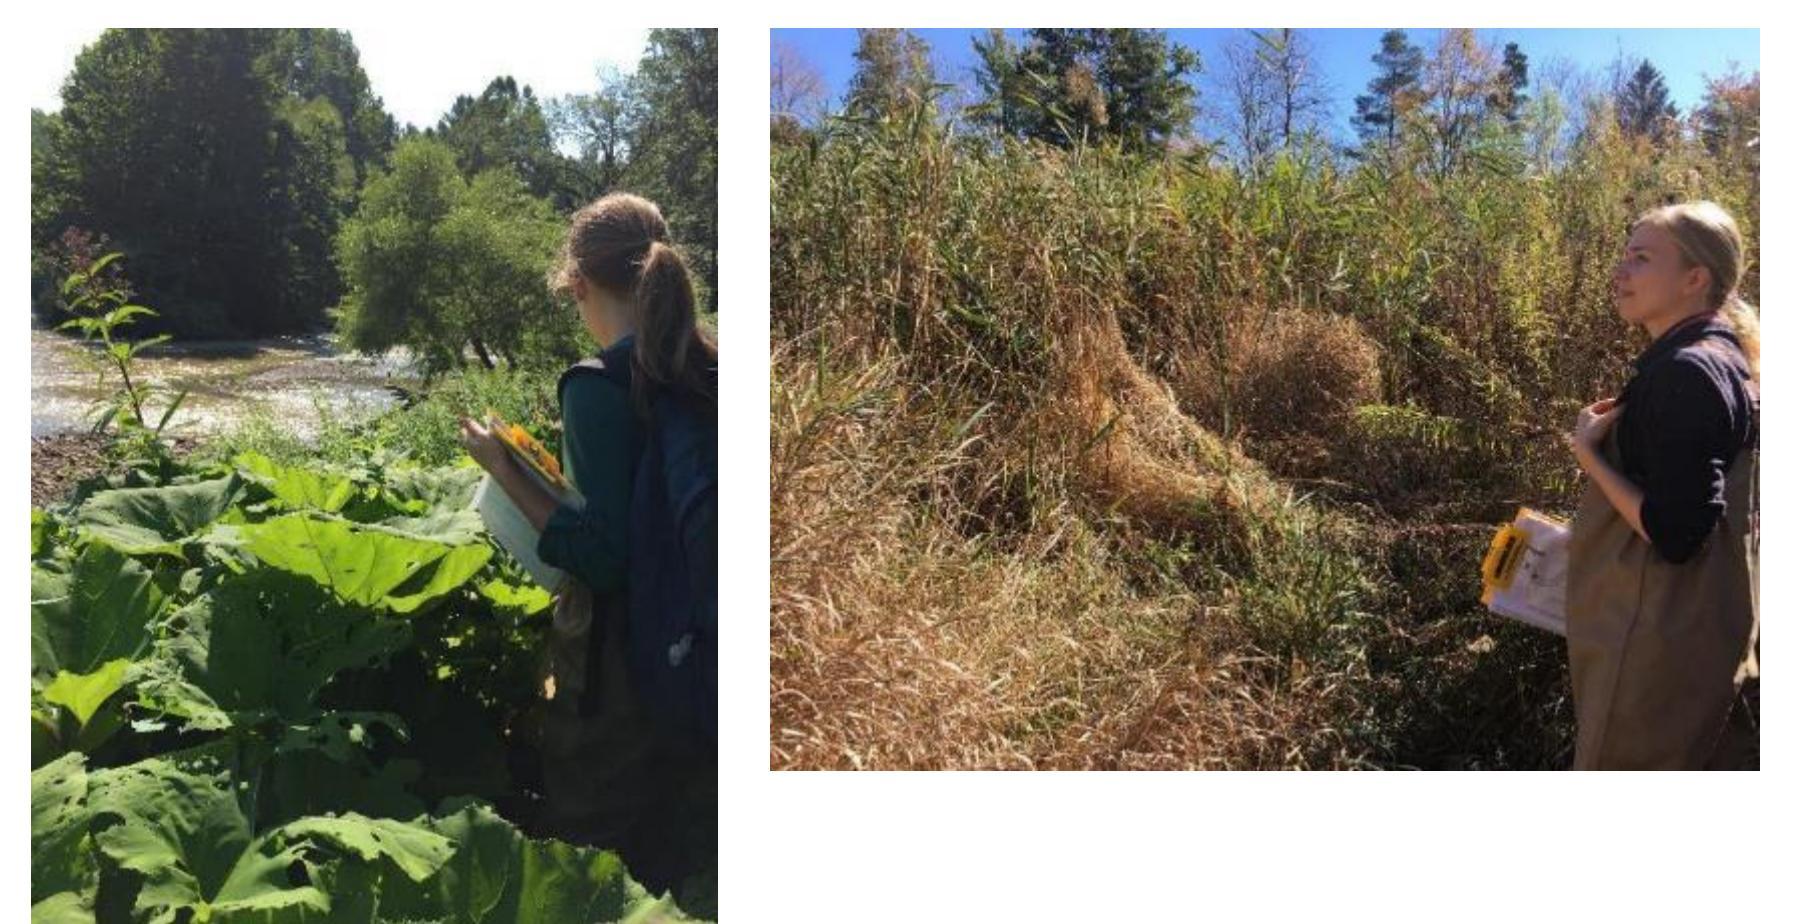
Some Initial Invasive Species Management May Be Necessary

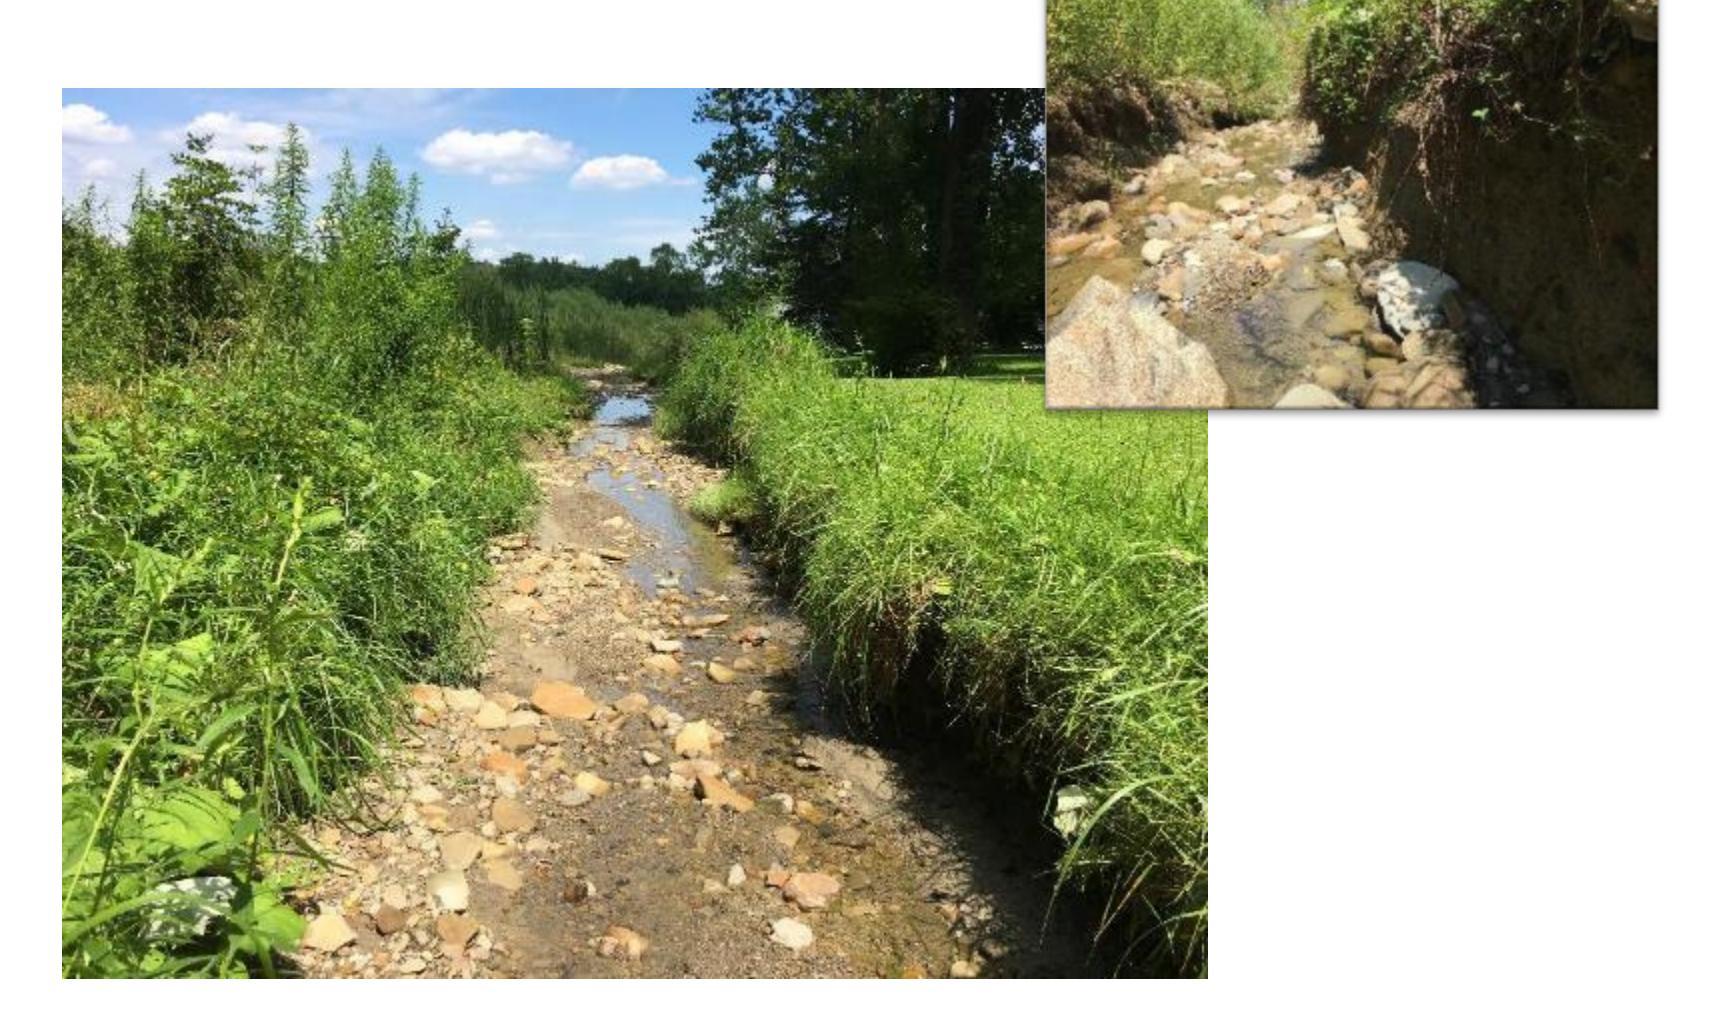
Best Landscape Management Practices Are Important

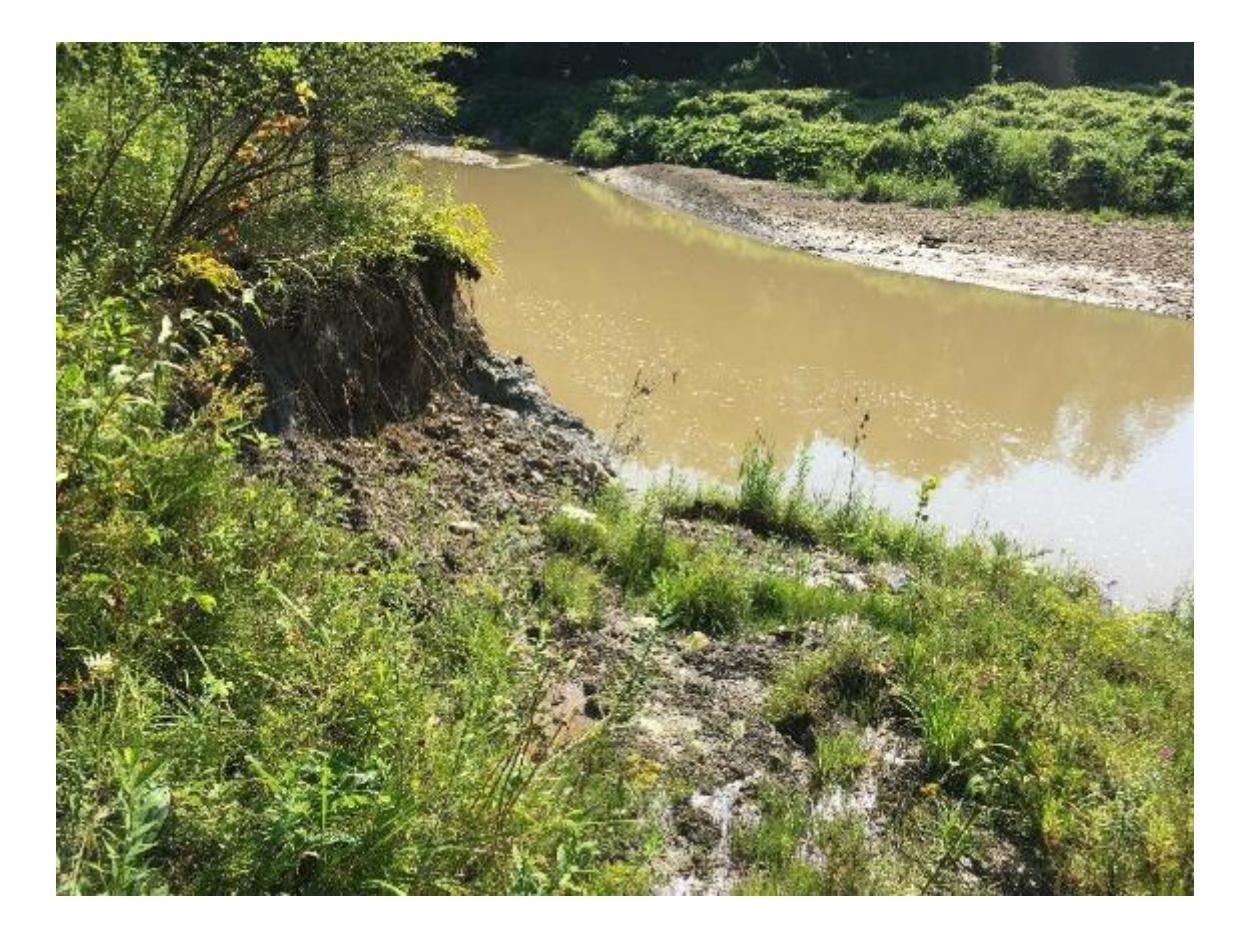
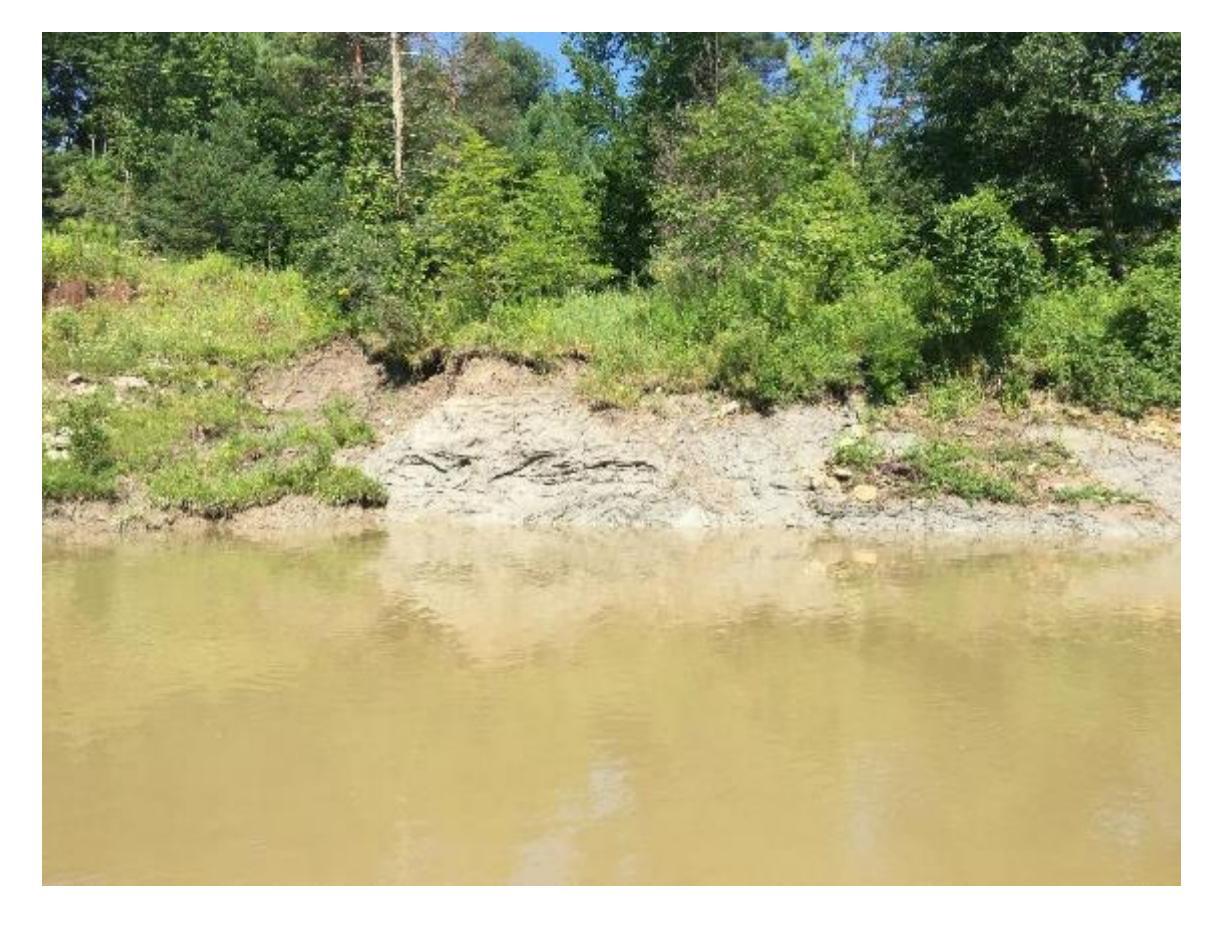
Downstream Consequences of Hardening Streambanks
