Case studies and tools: Assessing the performance of stream and wetland restoration

Presented by: Kimberly Brewster Senior Project Manager Chagrin River Watershed Partners, Inc.

Case Studies and Tools: Assessing the Performance of Stream and Wetland Restoration

October 24, 2018

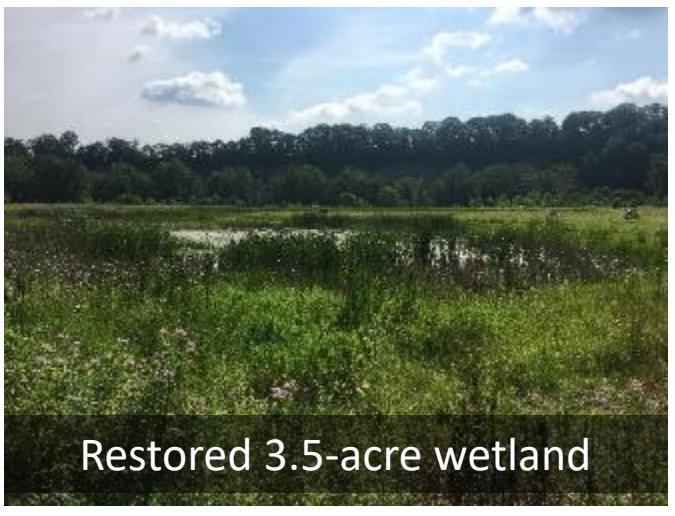
Indicators of improved floodplain access

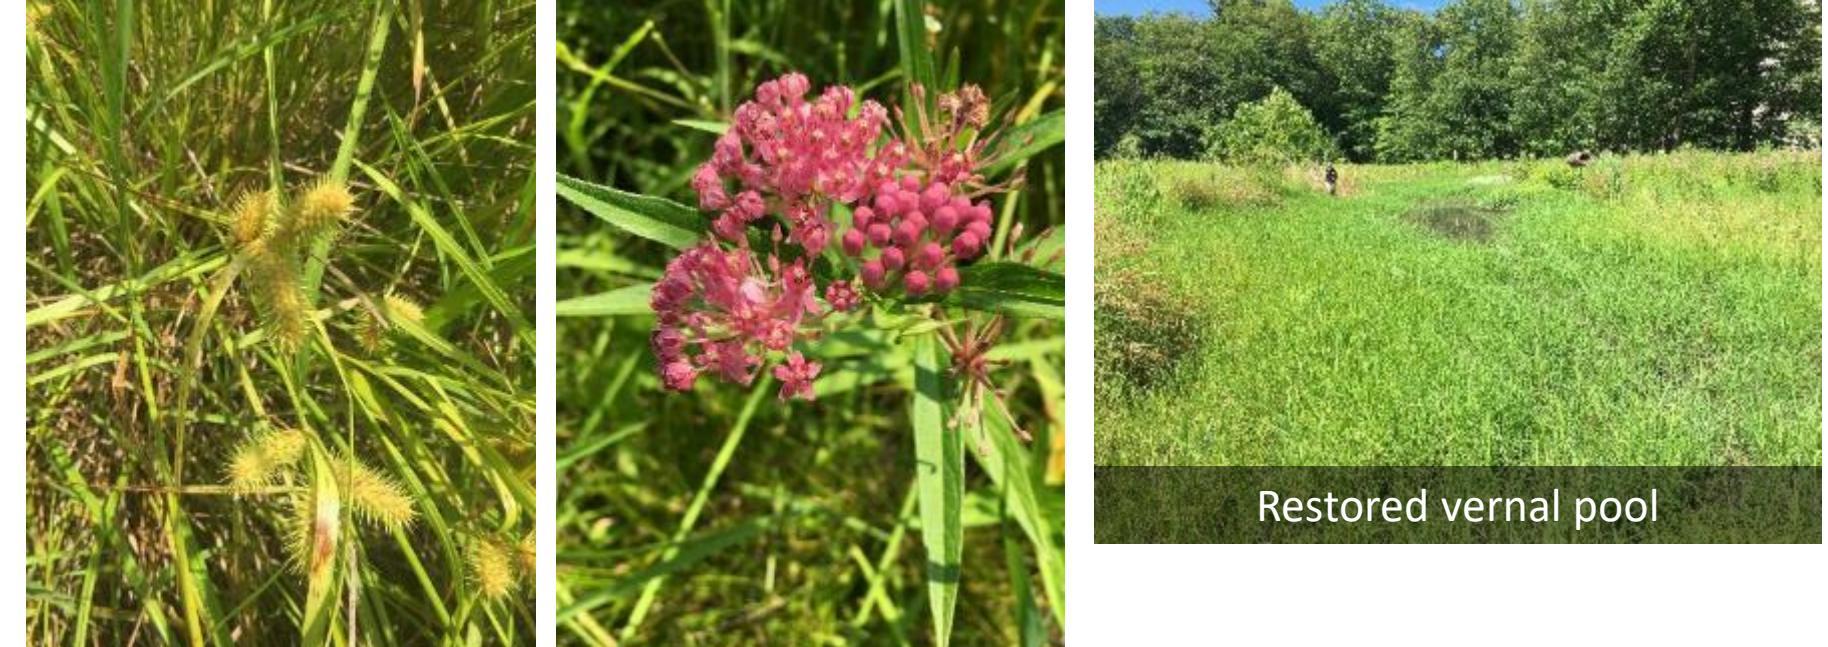
Restored forested floodplain, wetland, vernal pool, and meadow habitats

- 2017 Results
 - QHEI score = 80.5 ("Excellent")
 - ORAM scores = Category 2
 - Riparian vegetative cover >95%
 - ~ 10% cover of invasive plants
 - Phragmites
 - Narrowleaf cattail
 - Japanese knotweed
 - Butterbur
 - Purple loosestrife
 - Other, well established invasives
 - Visual evidence of floodplain access
- Partial attainment of WWH at 2 downstream sampling locations

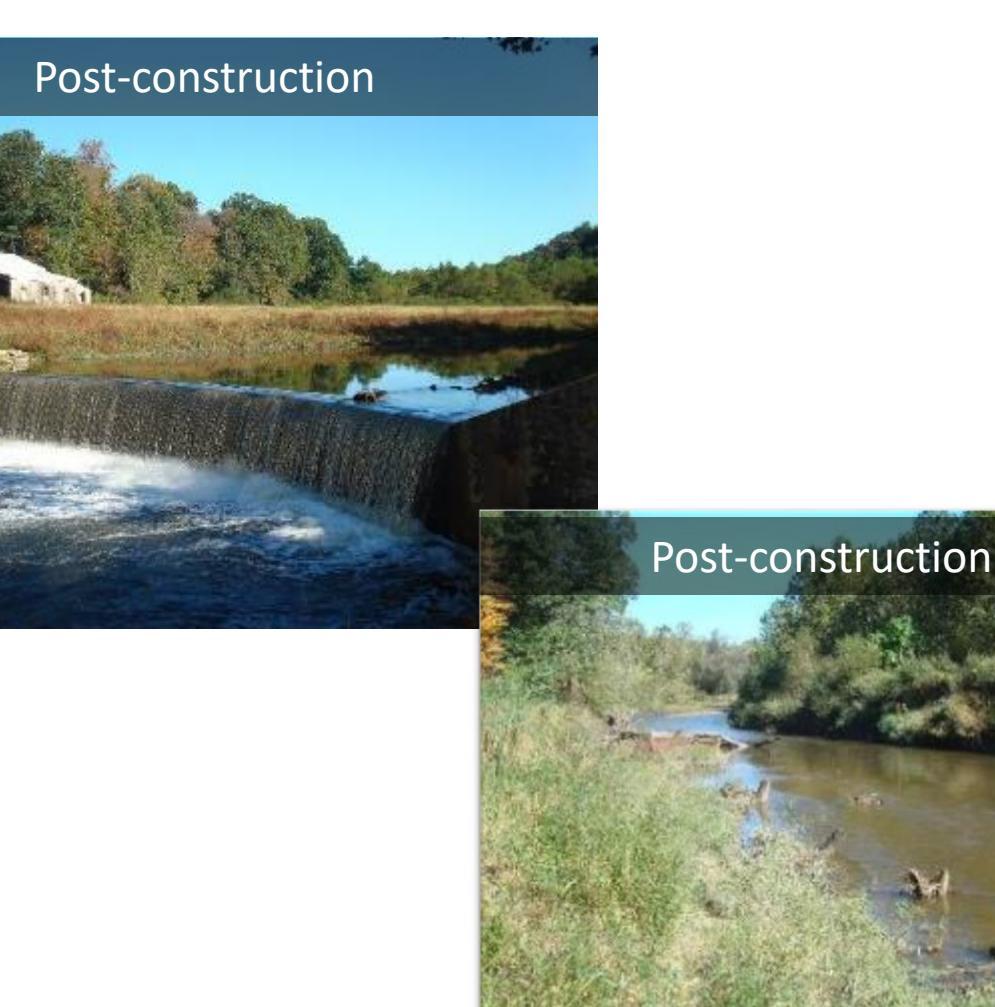
- QHEI scores
 - Within restoration reach: 70 "Good"
 - Downstream: 81 "Excellent"
- Riparian vegetative cover >95%
- ~ 25% cover of invasive plants
 - Phragmites
 - Narrowleaf cattail
 - Other, well established invasives
- Floodplain access not optimal upstream of modified spillway
- Nonattainment of WWH within restoration reach (IBI/ICI assessed by OEPA 2008)
- Full attainment of WWH at downstream of restoration (IBI/ICI assessed by OEPA 2014)

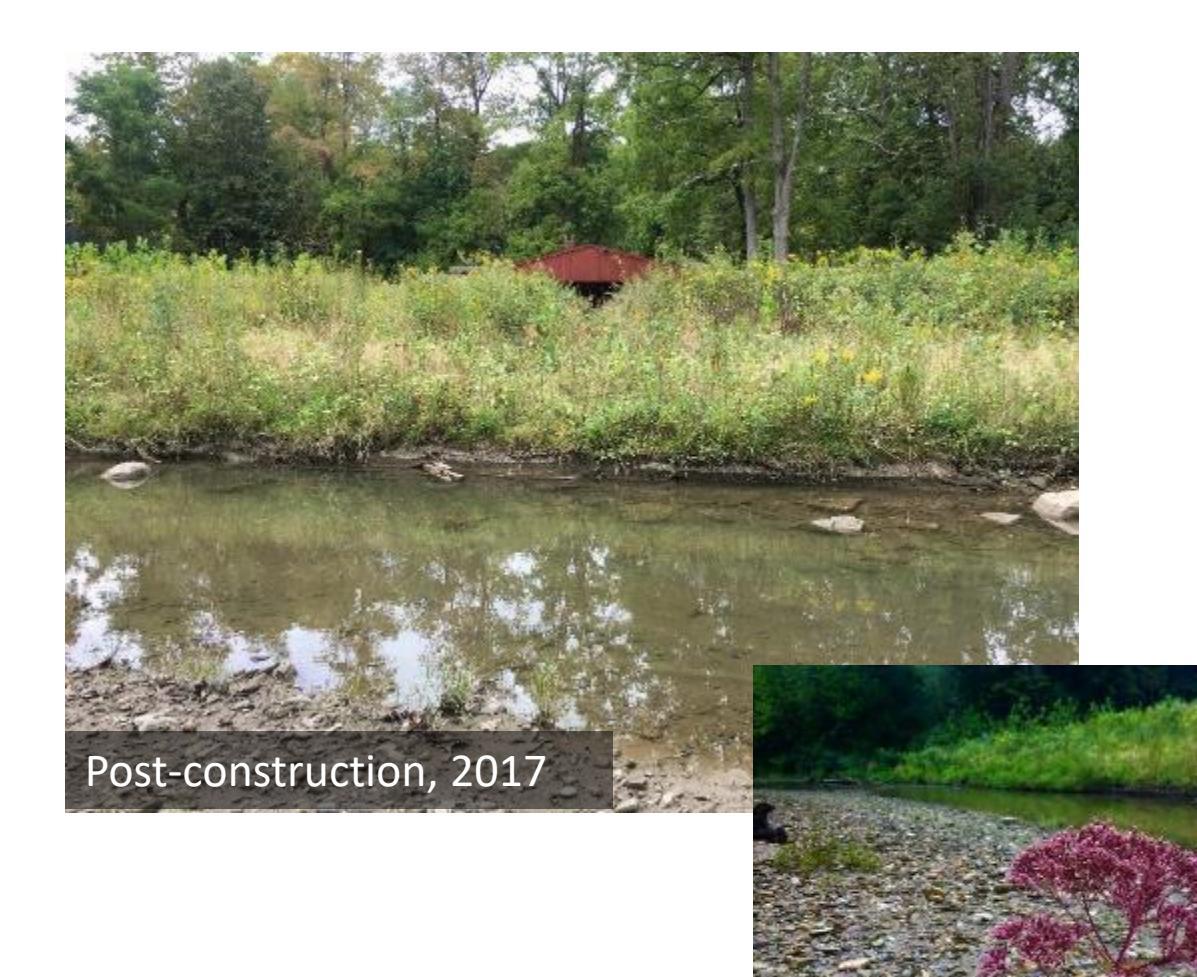
- 2017 Results
 - QHEI scores
 - Within restoration reach: 75.75 "Excellent"
 - Riparian vegetative cover >95%
 - Floodplain access good
 - <5% cover of invasive plants
 - Facilitation of native species establishment very good

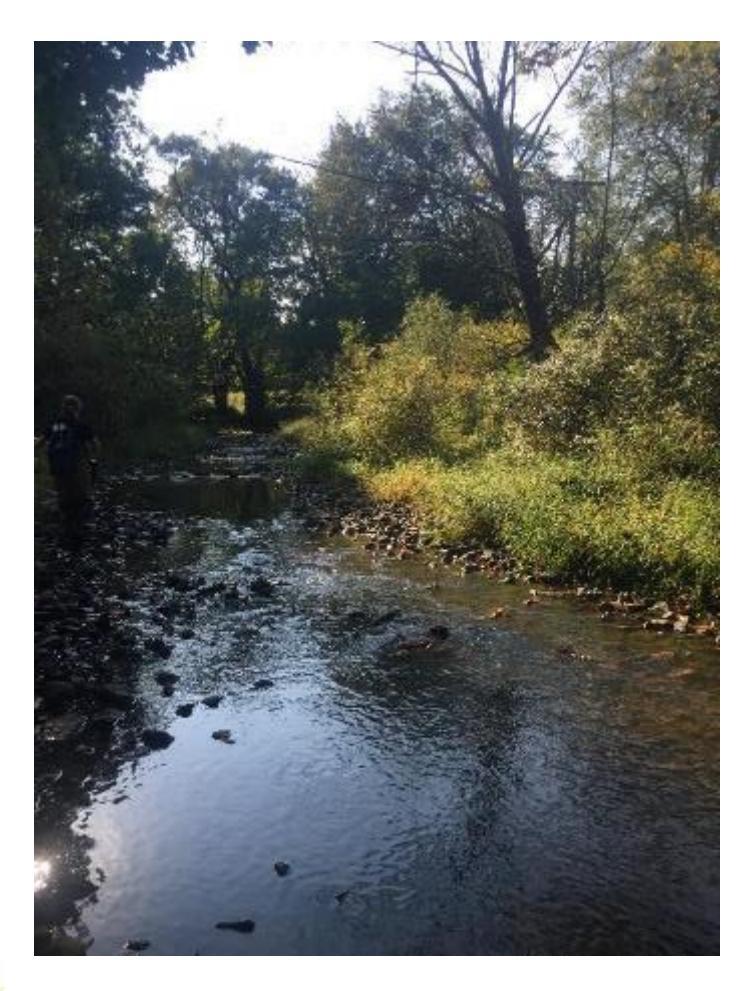
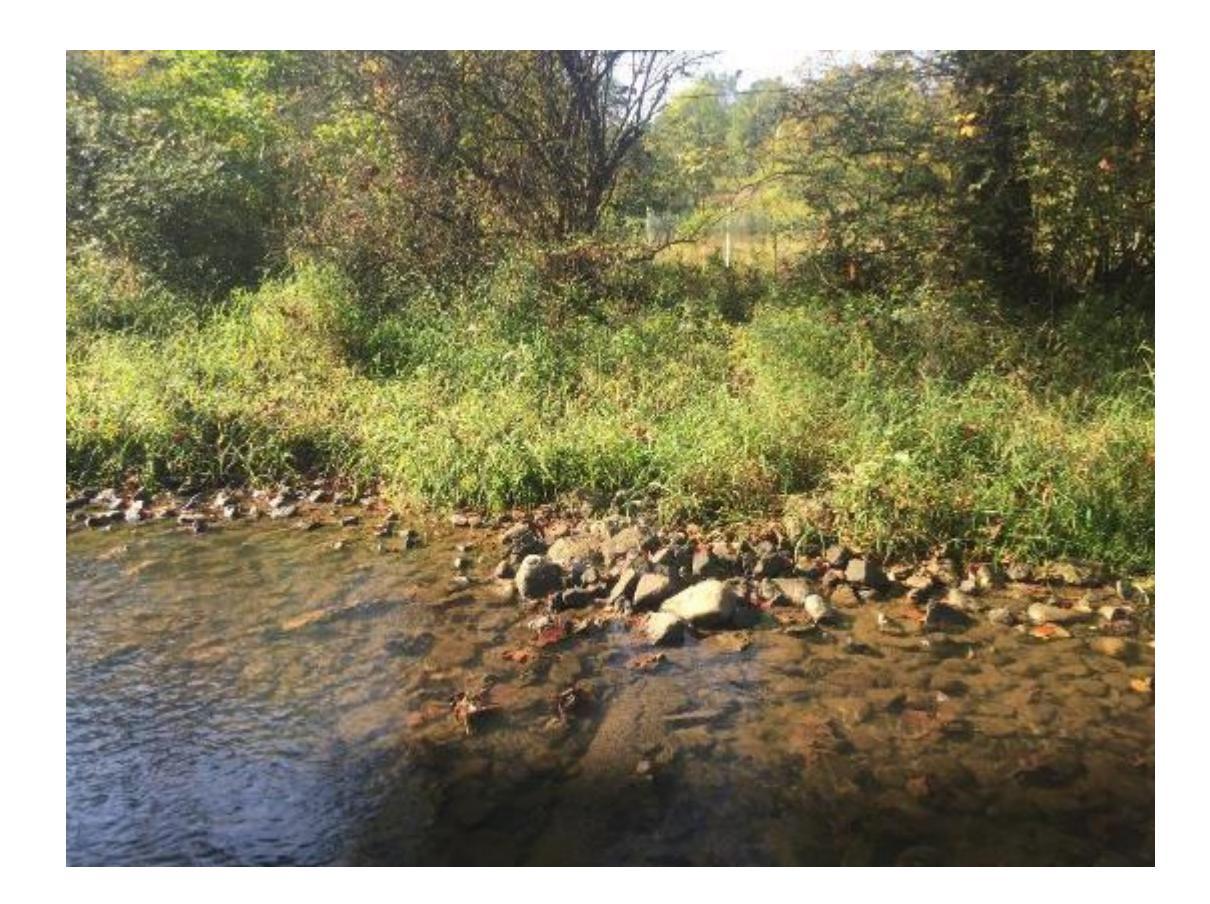
Aurora Branch Chagrin River Restoration (Aurora) - 2015

Establishment of Stream Characteristics Conducive to Nutrient Assimilation

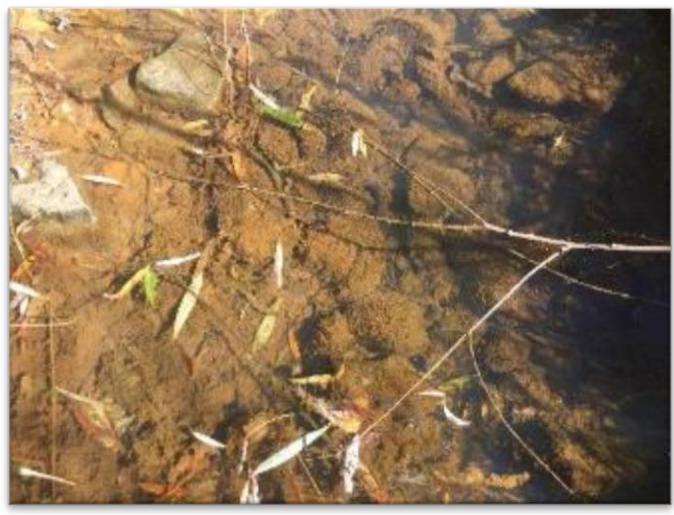
Some Initial Invasive Species Management May Be Necessary

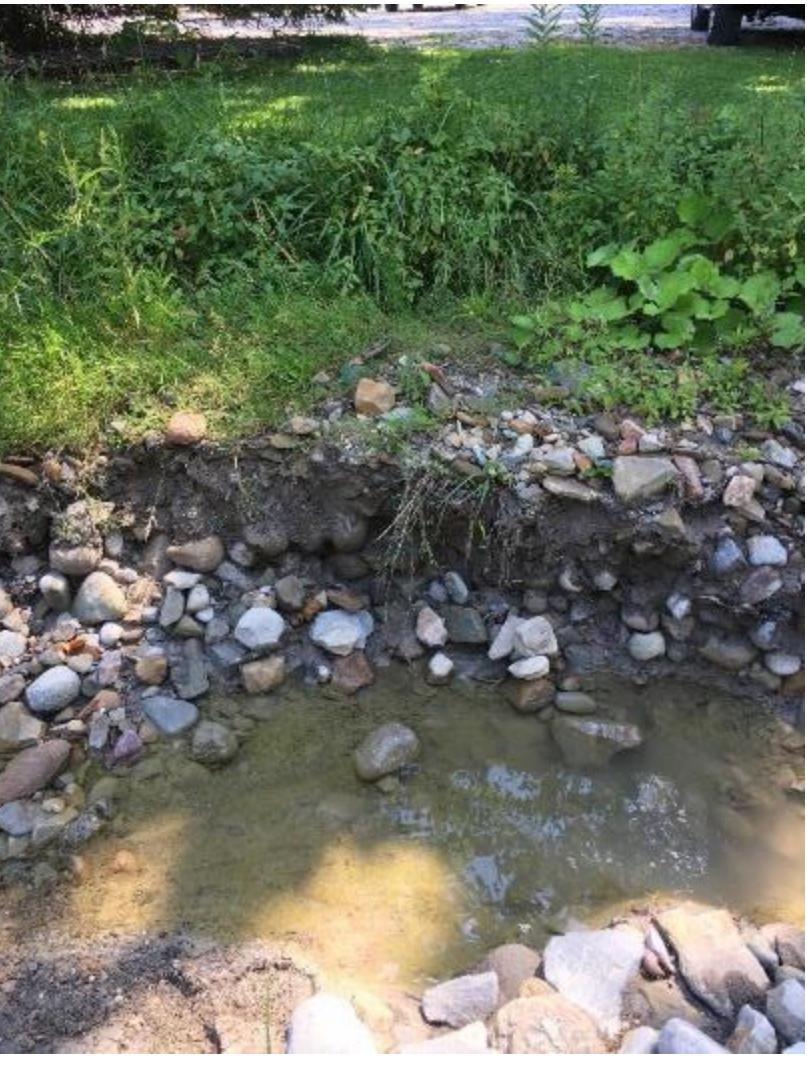
Best Landscape Management Practices Are Important
